Example Electrical Thermography Report

Practice Care Maintenance Services Ltd

4th March 2015

Customer Reference | ANOT – AB040315-2 |

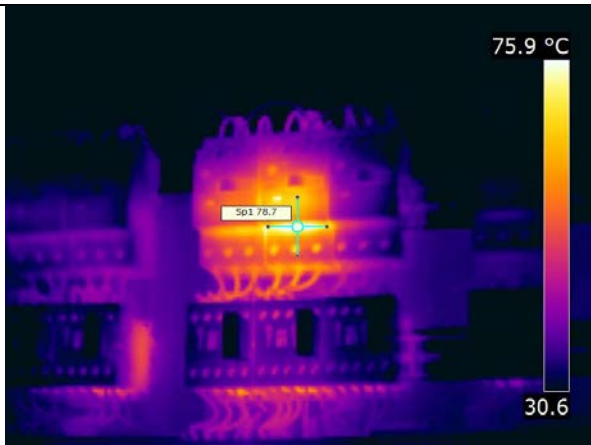
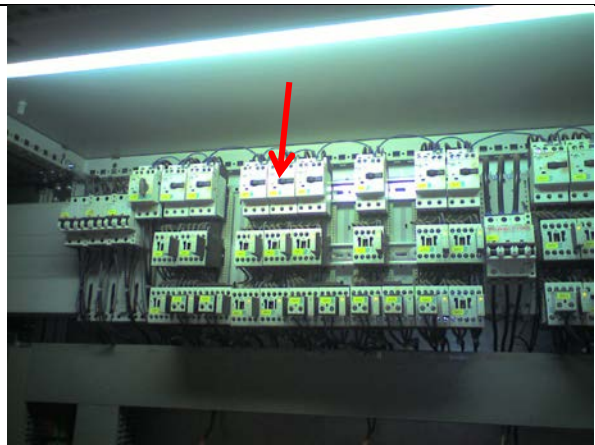
Location Description	Panel 10	Fault Location	MCB 45Q2 - Main Body
-----------------------------	----------	-----------------------	----------------------

Area Description	Control Room 4	Fault Description	Localised Internal Heating
-------------------------	----------------	--------------------------	----------------------------

Recorded Ambient: 22 °C Recorded Reference: 37 °C Recorded Anomaly: 78.7 °C	Observation Notes: An increase in the temperature of the MCB can be seen since the previous survey in December 2014.
--	--

Recommendations:
 As a precaution please schedule to replace the MCB due to the gradual increase in temperature.

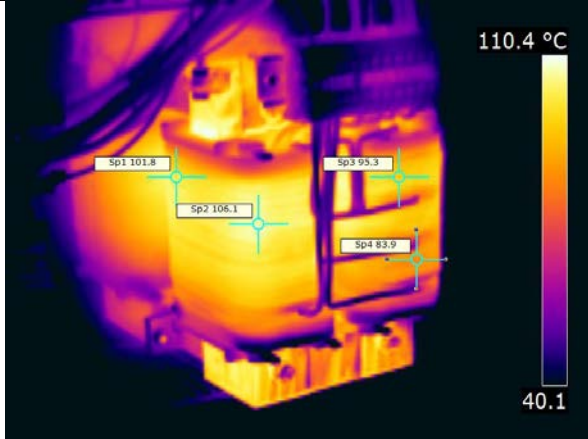
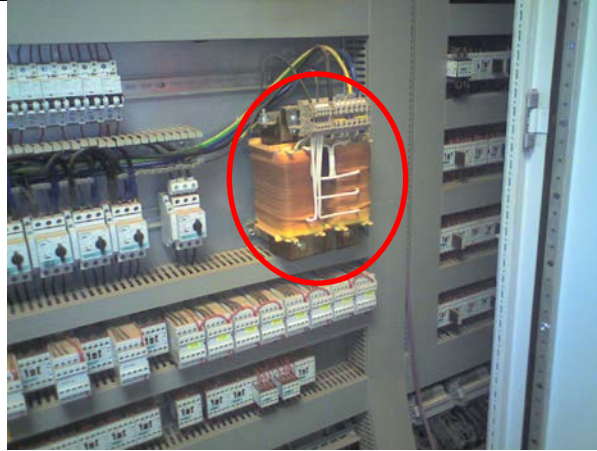
Location Description	Panel 63	Fault Location	Main Transformer – Left and Right Coil Legs
-----------------------------	----------	-----------------------	---

Area Description	Control Room 7	Fault Description	Overheating Transformer
-------------------------	----------------	--------------------------	-------------------------

Recorded Ambient: 24 °C Recorded Reference: 37 °C Recorded Anomaly: 106 °C	Observation Notes: The temperature of the transformer continues to increase with an increase evident on the left side coil. A discoloration in the insulation around the coil can now also be seen.
---	---

Recommendations:
 Please schedule to replace the transformer.

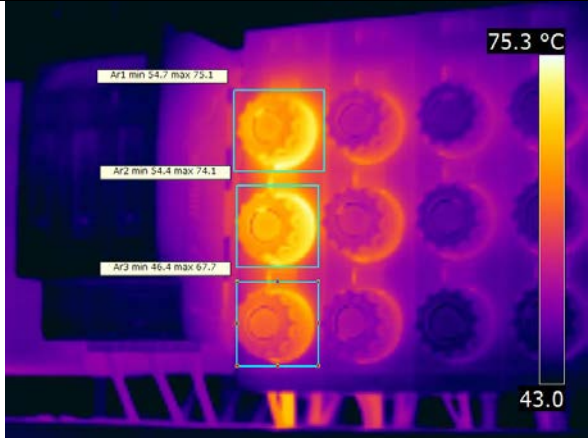
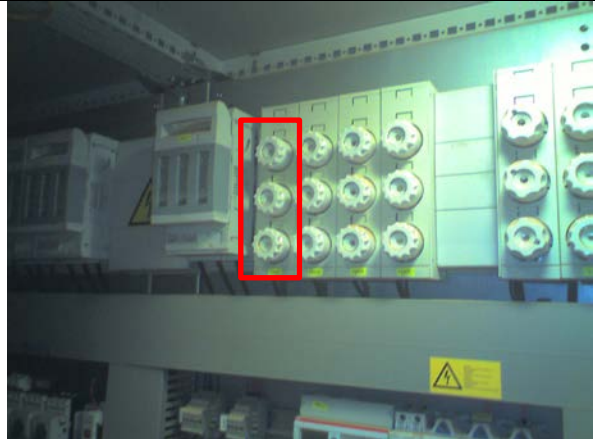
THERMOGRAPHY DETAILED EXCEPTION REPORT		Severity	
Area Description	Control Room 7	Fault Description	Differential temperature across 3 phase fuses
Location Description	Panel 65	Fault Location	F8401 Fuses
Thermal Image		Digital Image

Recorded Ambient:	24 °C	Observation Notes:	A differential in temperature can be seen across the three fuses with the client stating that there are known issues with failures of these fuses.
Recorded Reference:	32 °C		
Recorded Anomaly:	75 °C		
Recommendations:			
Please remove each fuse inspecting the contact surfaces for oxidisation. The fuses carrier / holder should also be inspected and cleaned as required. When refitting please ensure all three fuses are secure and that the phase loading is balanced.

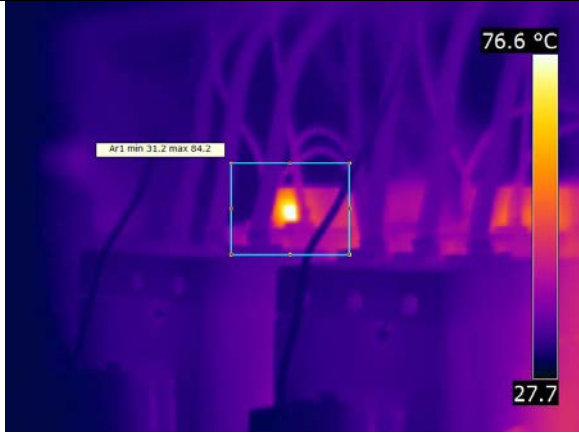
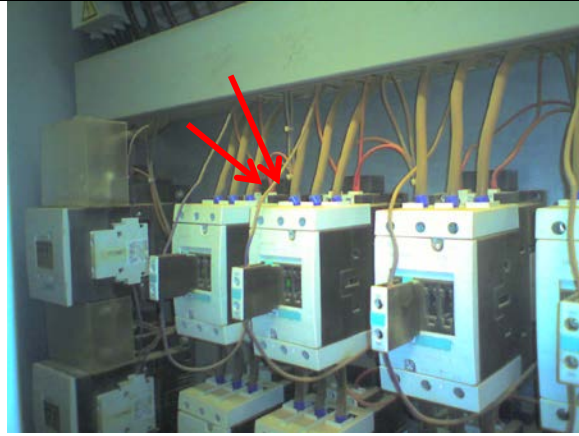
THERMOGRAPHY DETAILED EXCEPTION REPORT		Severity	
Area Description	Control Room 14	Fault Description	Localised internal heating
Location Description	Panel 29	Fault Location	Add on 'disconnect module'
Thermal Image		Digital Image

Recorded Ambient:	25 °C	Observation Notes:	
Recorded Reference:	34 °C	An area of heating can be seen from the add-on units which were confirmed by the client to be related to a safety disconnect circuit. This is likely to indicate a developing internal fault.	
Recorded Anomaly:	84.2 °C		
Recommendations:			
If subsequent surveys highlight an upward trend in temperature recommendations will be made to replace the add-on unit.

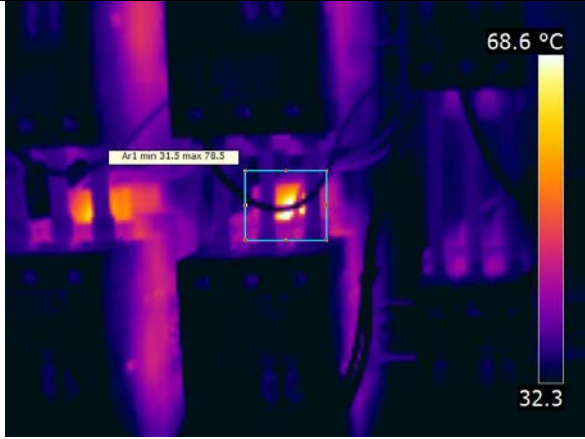
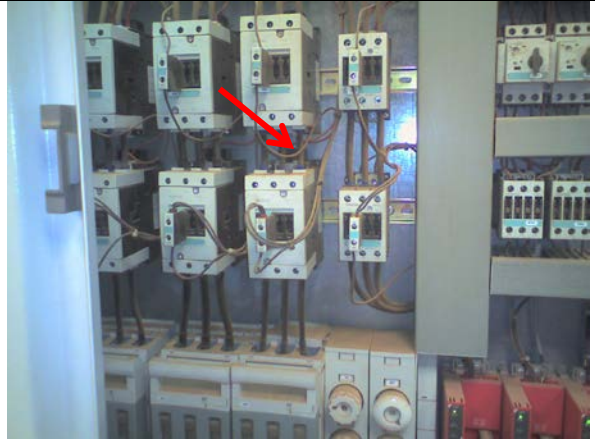
THERMOGRAPHY DETAILED EXCEPTION REPORT		Severity	
Area Description	Control Room 14	Fault Description	Localised internal heating
Location Description	Panel 29	Fault Location	Add on 'disconnect module'
Thermal Image		Digital Image

Recorded Ambient:	25 °C	Observation Notes:	
Recorded Reference:	34 °C	An area of heating can be seen from the add-on units which were confirmed by the client to be related to a safety disconnect circuit. This is likely to indicate a developing internal fault.	
Recorded Anomaly:	78.5 °C		
Recommendations:			
If subsequent surveys highlight an upward trend in temperature recommendations will be made to replace the add-on unit.
